January 22, 1998

Reference: EPA Contract No. 68-W4-0006; Work Assignment No. R05020; Daelyte Service Company/Astro Maintenance; Detroit, Michigan; EPA ID No. MID006537336; Site Inspection Trip Report; Task 06 Deliverable

**DAELYTE SERVICE COMPANY/ASTRO MAINTENANCE  
EPA ID No. MID006537336**

**SITE INSPECTION TRIP REPORT**

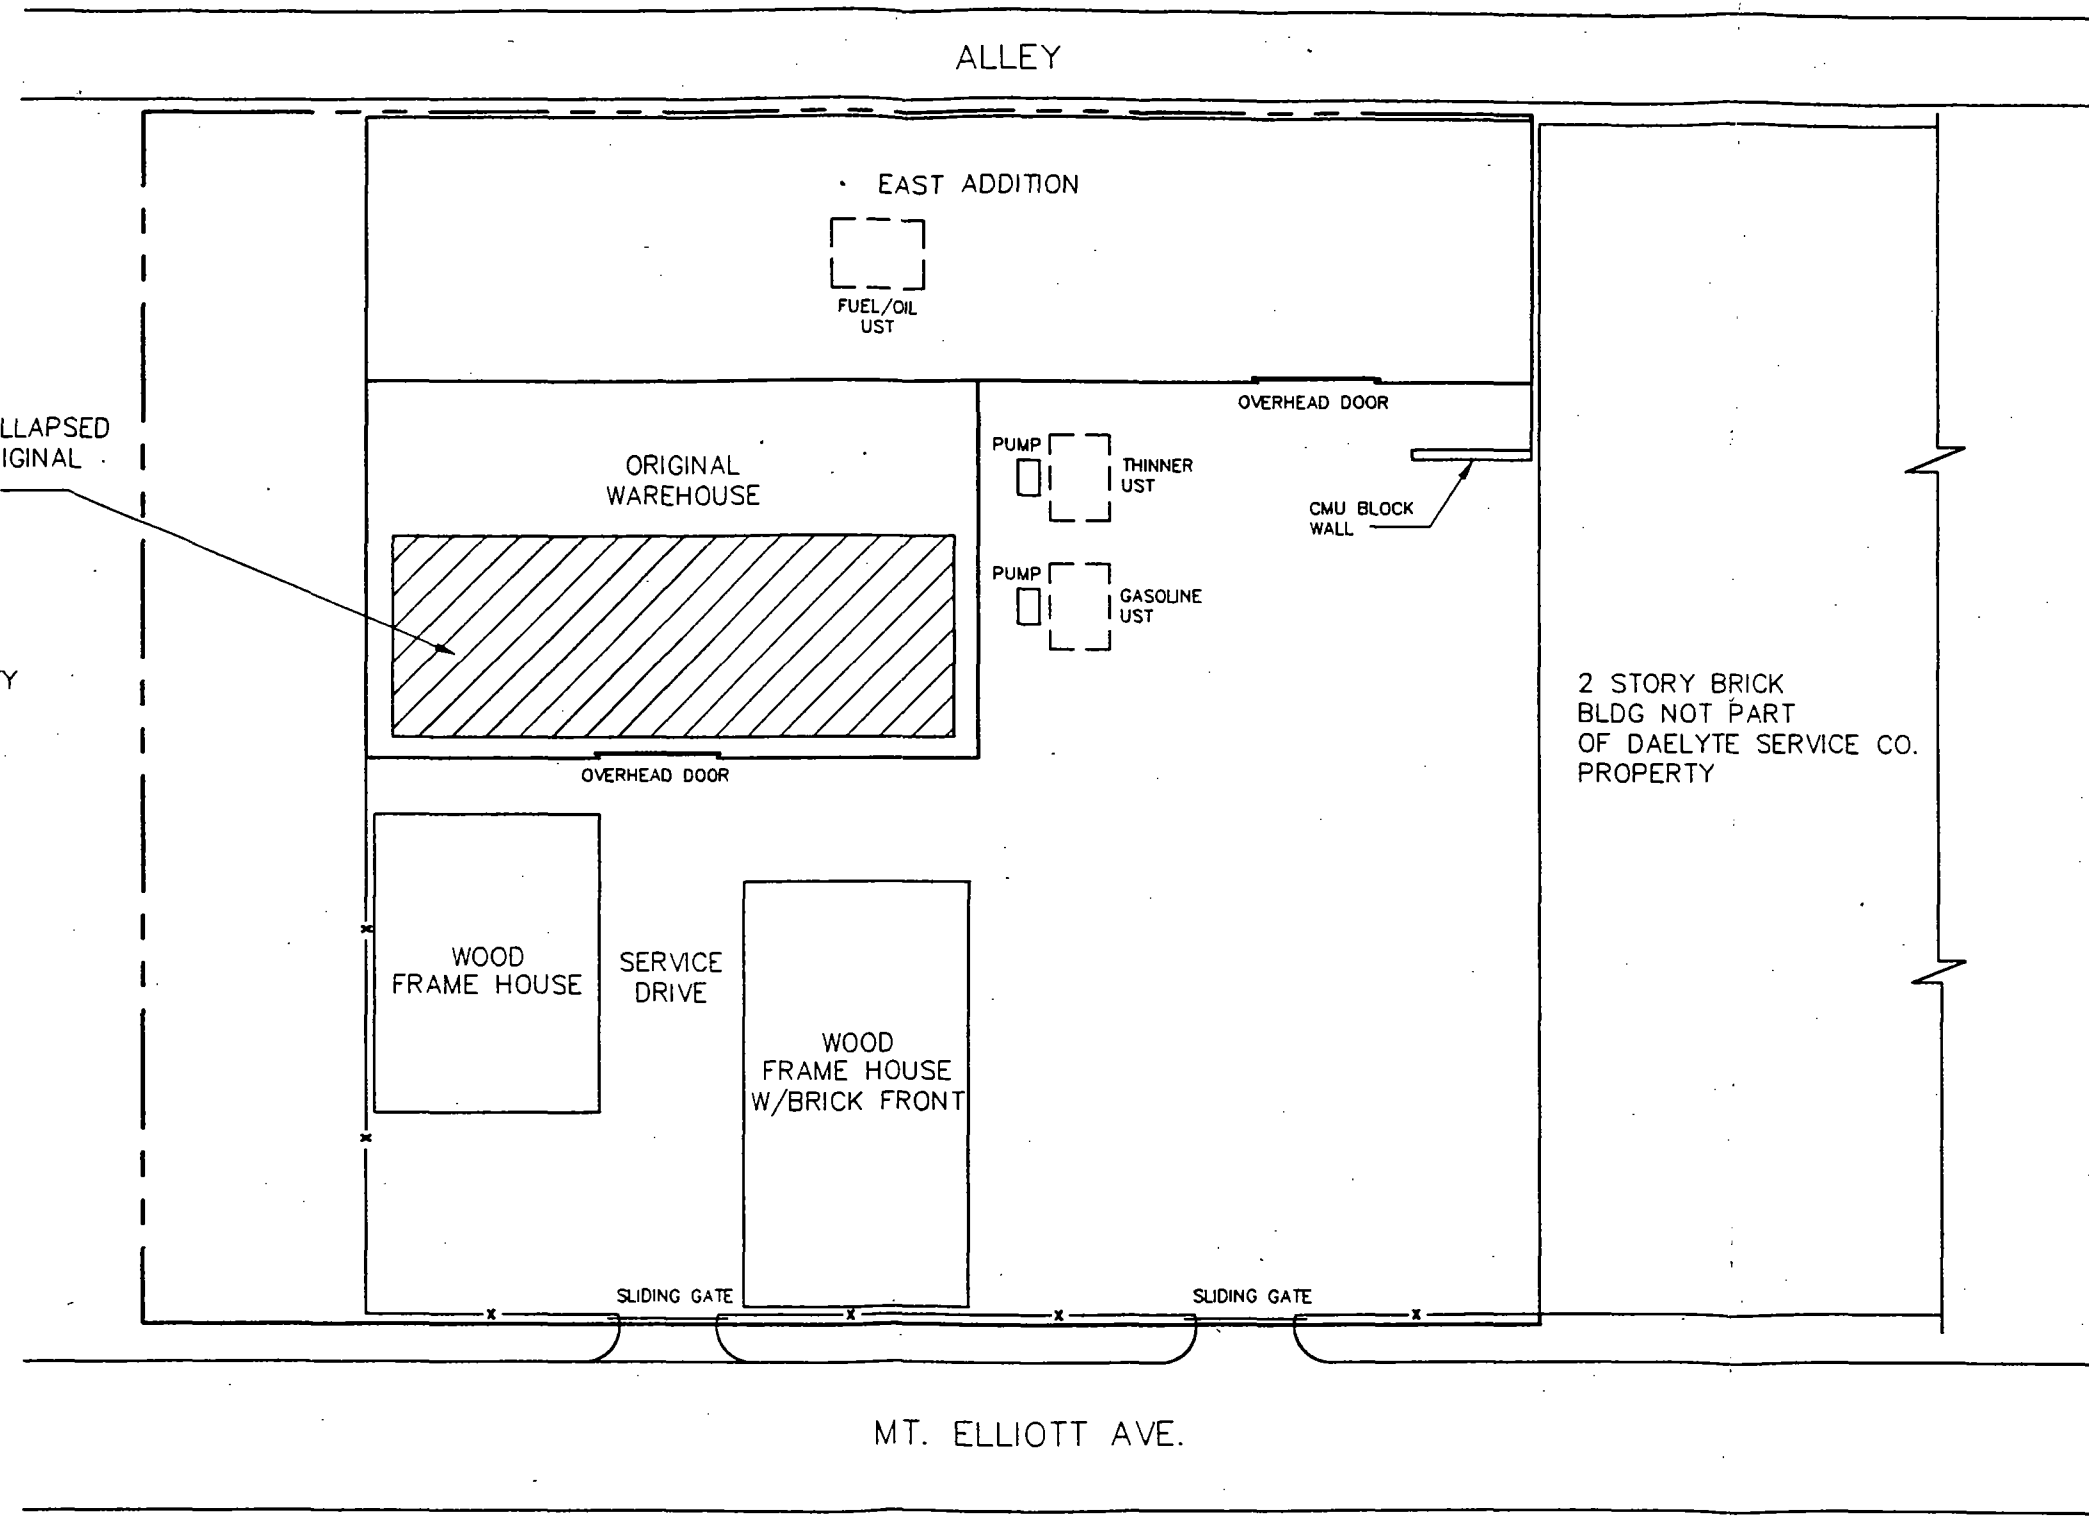
**FIGURE 2**  
**FACILITY PLAN**

AREA OF COLLAPSED  
ROOF ON ORIGINAL  
WAREHOUSE

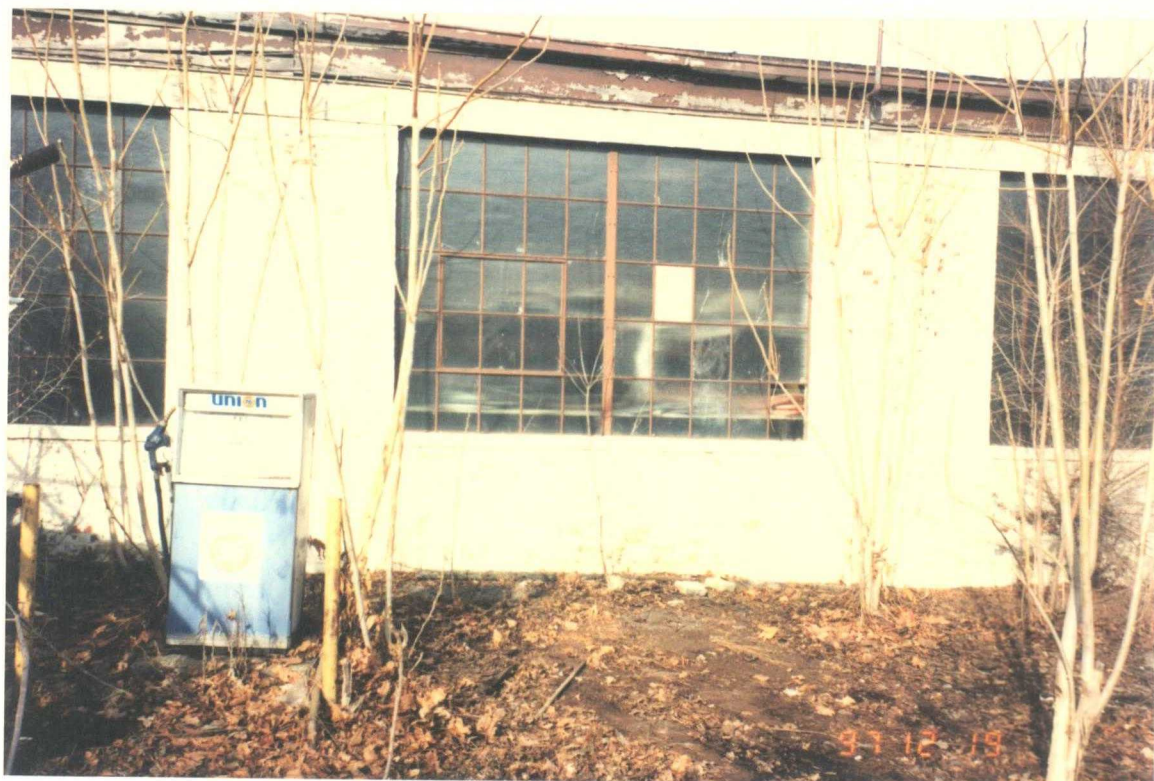
Photo No.: 1-3  
Date: 12/19/97

Description: Gasoline dispenser pump located at AOC A. Top portion of UST vent-pipe may be seen at the roof-line between the two windows at the right of the photograph.

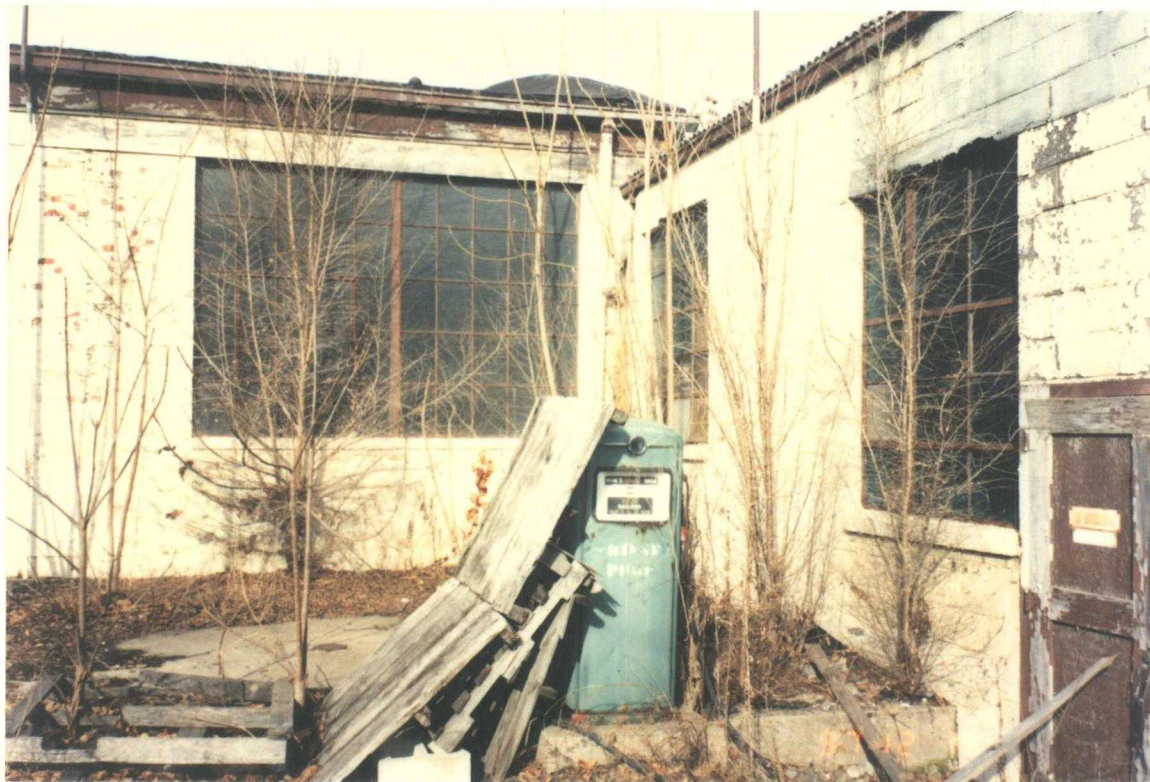
Photo No.: 1-4  
Date: 12/19/97

During the SI the protective covers for the fill pipes were removed to check for remaining product in either UST. Upon removal of the fill pipe protective cover for the East UST it was discovered that the fill pipe protective cover casing had been filled with sand. As a result, the SI Team was unable to determine if product was present in this UST. The fill pipe for the West UST was still accessible. It was opened and a rod was lowered into the UST where it was determined that the bottom was approximately 8 feet below grade. Approximately 1-foot of product was found to be remaining in the bottom of the UST. The odor on the rod was similar to that of gasoline. The capacity of the USTs in AOC A is unknown.

Description: "Thinner" dispenser pump located in AOC A. Rusted, UST fill-port cover may be seen in the concrete pad to the left of the pump and the suspected vent-pipe for the UST may be seen to the right of the pump.

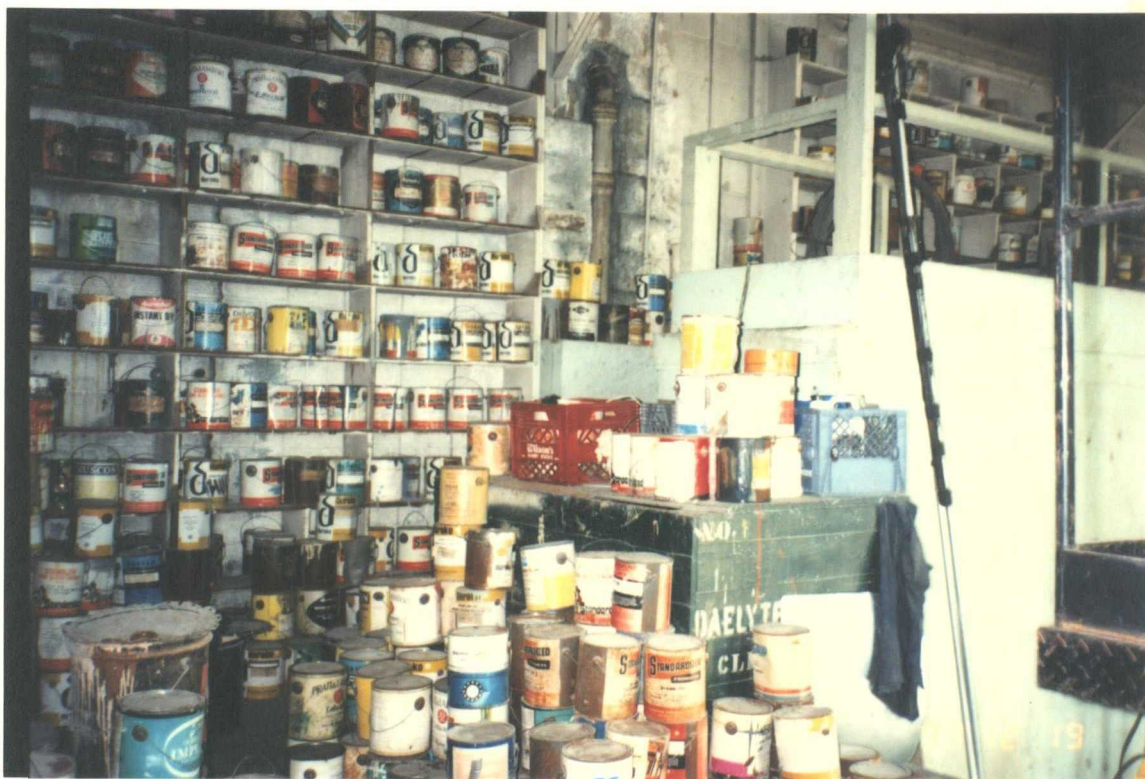
Photo No.: 1-9  
Date: 12/19/97

Description: East-central portion of east addition showing storage of numerous 1-gallon paint cans. The area shown in Photograph 1-8 may be seen in the upper right portion of this photograph.

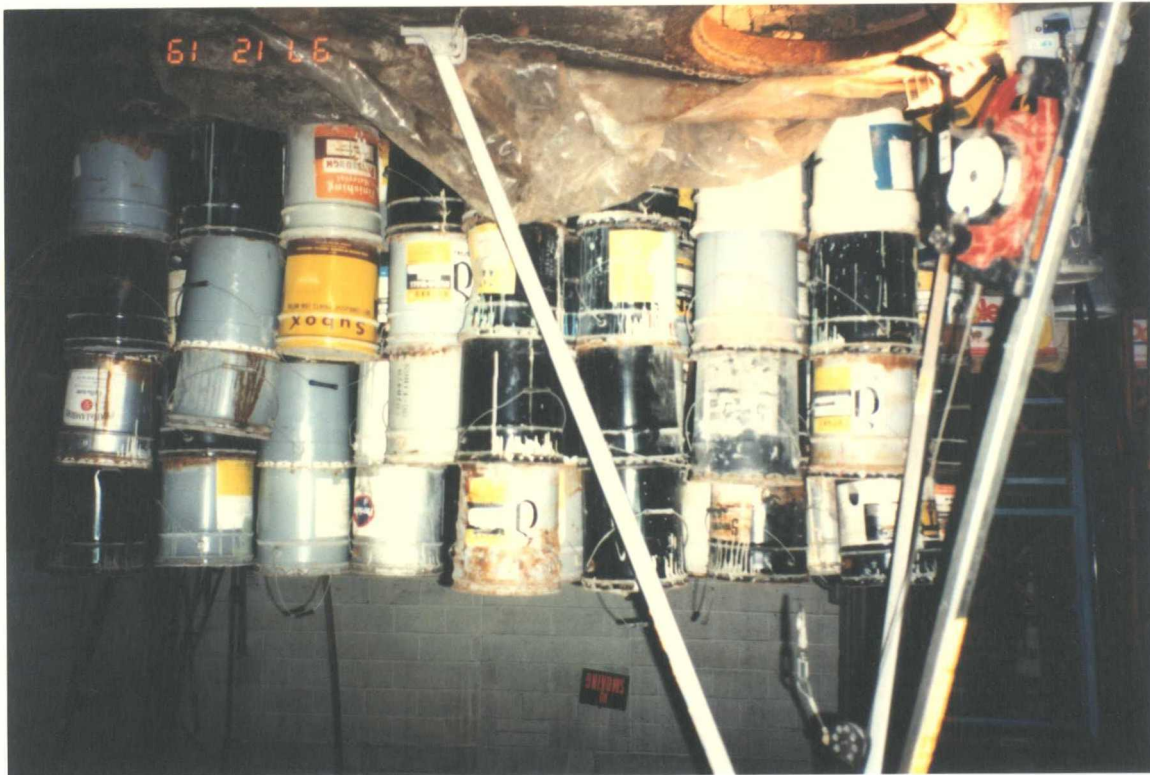
Photo No.: 1-13

A member of the SI Team was lowered into the manhole utilizing confined space entry procedures to check if the UST was empty. The cap on the standpipe was removed and a rod lowered into the tank. The bottom of the tank is approximately 10 feet below the finished floor found under the manhole. Approximately 8 inches of product with the odor of fuel oil was found remaining in the bottom of the tank. The capacity of this UST is unknown.

Description: North portion of the east addition showing five-gallon paint cans. The manhole which provides access to AOC B may be seen at the base of the photograph. The tripod set-up over the manhole was used during the site inspection to access the probable fuel oil UST fill pipe.

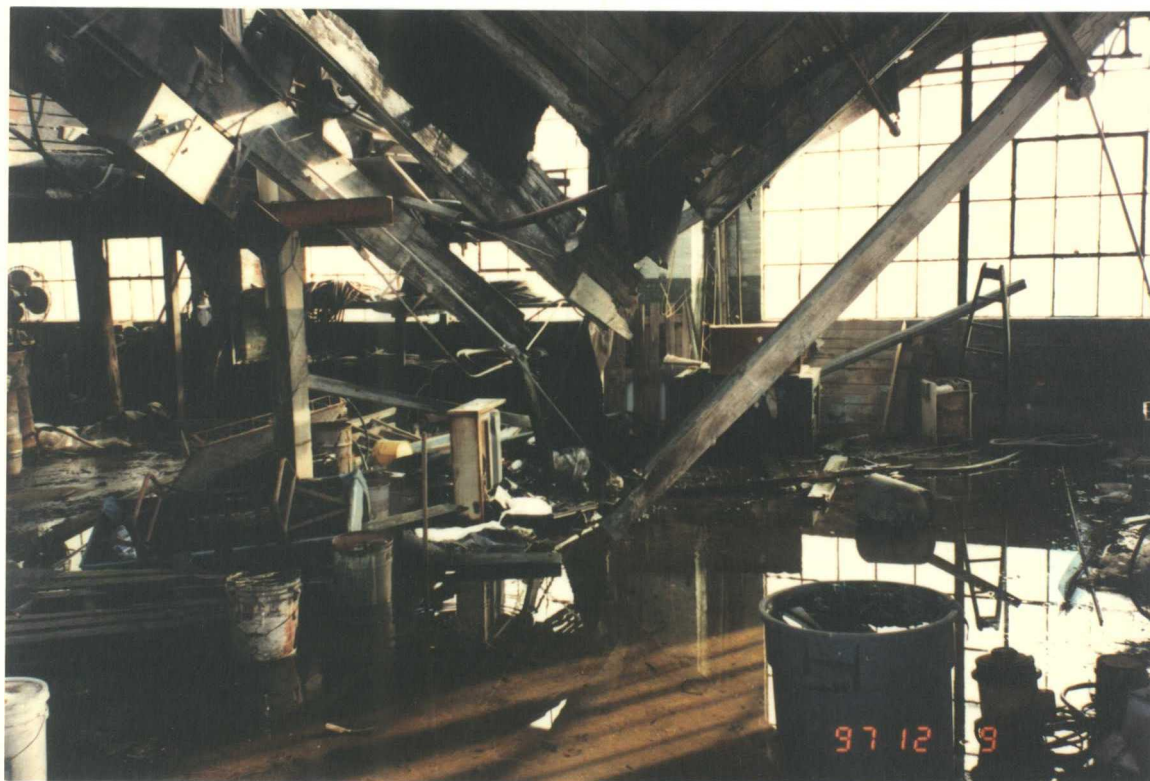
Photo No.: 1-15  
Date: 12/19/97

The building consists of an original structure about 50 feet by 80 feet and a later addition of about 33 feet by 155 feet to the east (see Figure 2). The original structure consists of a block bearing wall with a timber roof supported by timber bowstring trusses spanning the 80 foot section. The roof is partially collapsed and the building is in a dangerous condition. The 80 foot-long west wall is very unstable and leaning outward. This wall still supports heavy timber rafters. Disturbances, heavy snow, or wind loads may lead to further collapse. The first bowstring truss to the east of the west wall is completely collapsed with the ends still resting upon the north and south walls and portions of the truss are either in contact with the floor or partially supported by the steel bridge crane framing found in the center of the

building. Rafters are still bearing on part of the truss, but could easily slip off, leading to further collapse. The portion of the roof which remains appears to be stable but this is deceiving, since the lateral support provided by the roofing system is compromised. Rafters are no longer adequately supported by the bowstring truss and are in danger of slipping off the truss. The truss itself is almost certainly rotating about its longitudinal axis. Again, disturbances, heavy snow, or wind loads may lead to further collapse. The north and south walls appear to be stable at this time, but could easily be tipped over if the remaining portions of the roof collapse further.

Description: Collapsed roof in southern portion of original warehouse. Water may be seen accumulated on the floor. A suspected floor drain (inoperative) was believed to be observed at the base of the broom handle seen sticking out of the ground in the left-central portion of the photograph.

No work should be conducted within or around the original 50 foot by 80 foot part of the warehouse building because of the danger of further collapse, especially since any disturbance to the remainder of the structure can bring about a sudden collapse of the entire remaining structure. Prior to conducting any remedial work, damaged parts of the roof must be removed or stabilized. Walls must also be braced. In lieu of this, the original building could be razed in its entirety.

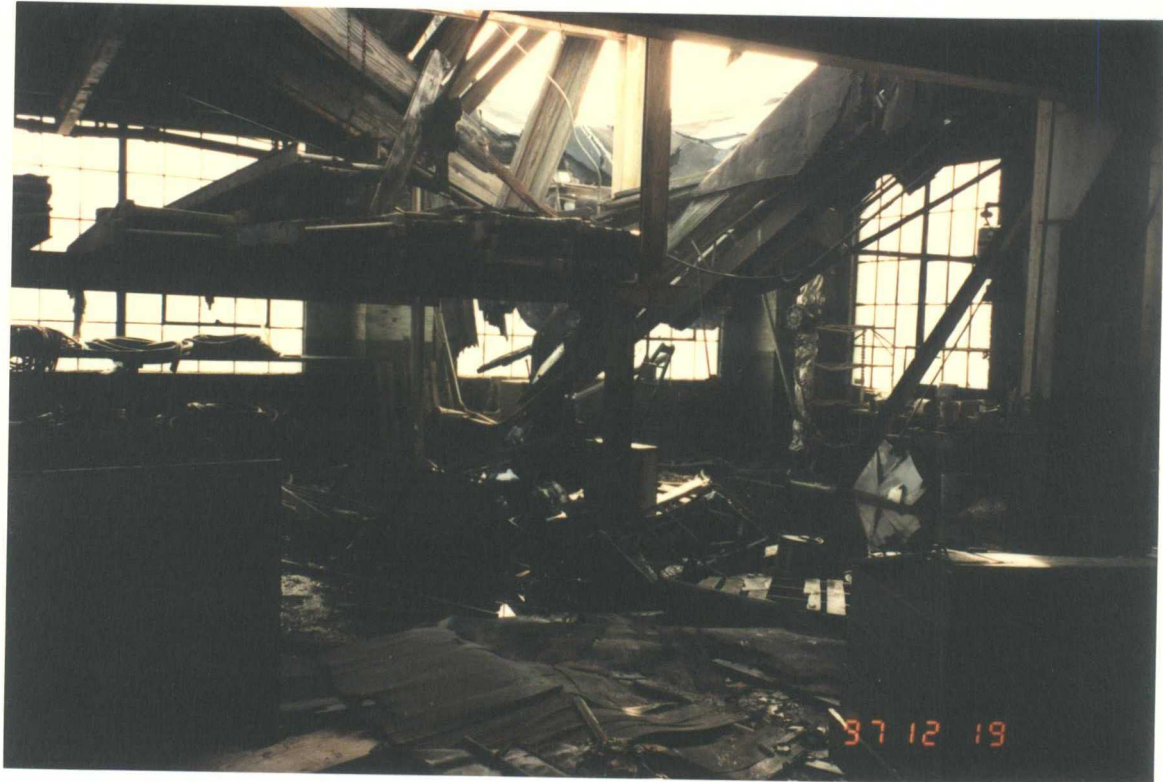
Description: Collapsed roof on the original warehouse viewed to the southwest.

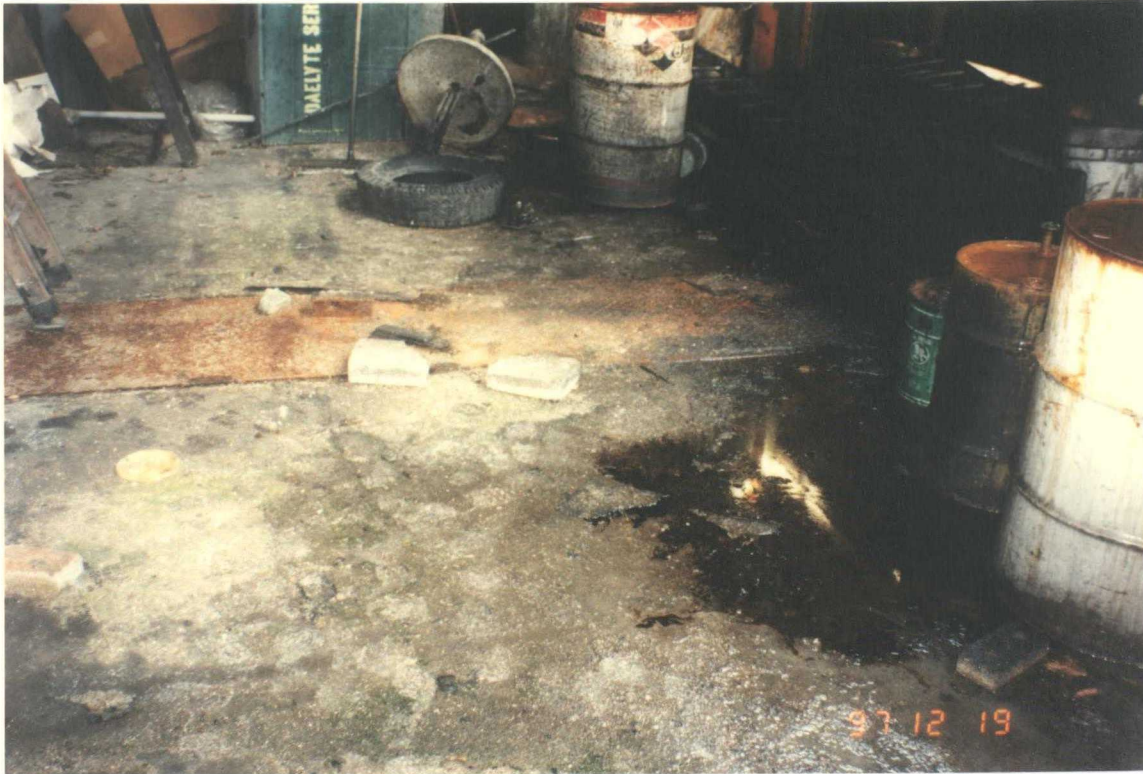
Photo No.: 1-16  
Date: 12/19/97

Description: Metal cover over suspected access trench under western portion of original warehouse. Area was not investigated further because of unsafe structural conditions. A small puddle of oil may be seen on the ground to the right of the photograph. The source is likely one of the drums adjacent to the puddle.

12/19/95  
The only unanswered question  
is what is under the metal  
plate on the ground in the  
garage. Dave Rittmeyer said that  
area of the building was very  
unsafe. The joists had separated  
from the wall and the caved  
in roof was exerting outward  
pressure. May just be an  
access for electrical etc to  
the crane.

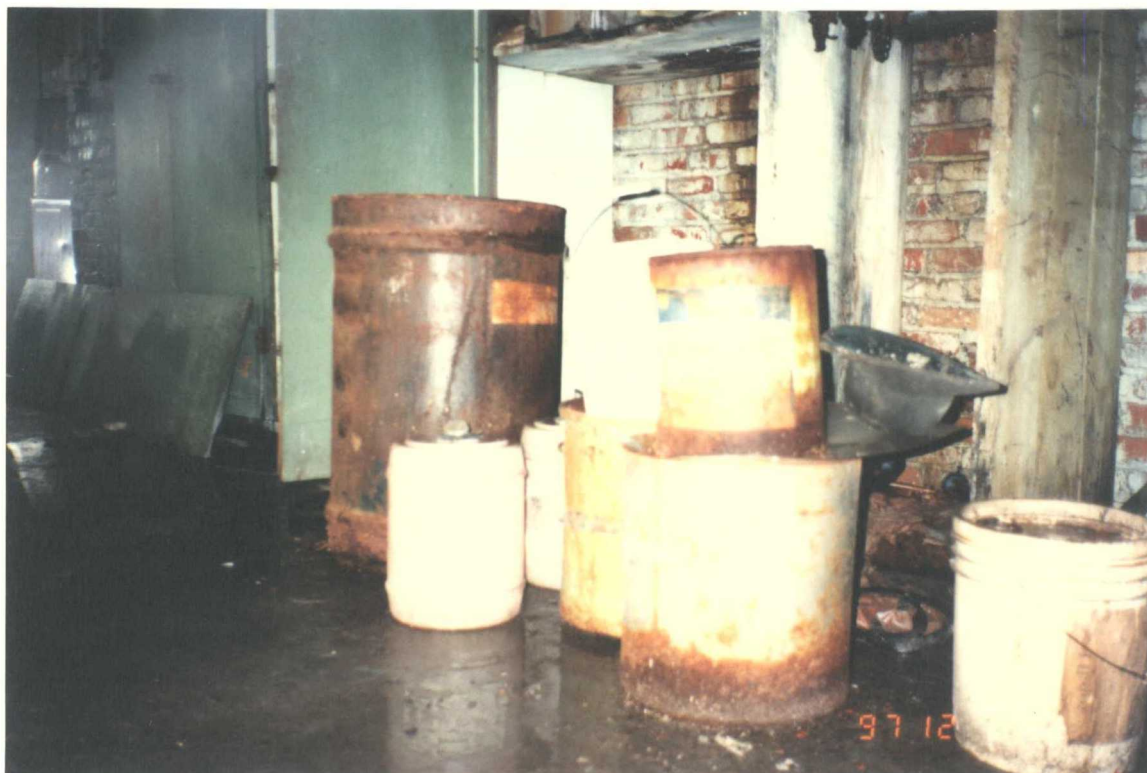
Photo No.: 1-17  
Date: 12/19/97

An approximately 35-gallon corroded drum was observed in the northern portion of the original warehouse. There were numerous smaller containers in the vicinity of this drum that were labelled as acid based metal cleaners or etchants. The drum was labeled as: Abbott AC-89, Acid Detergent Brick Cleaner. Among other information on the label of the drum was a phone number to call for information on AC-89 (313/399-4000).

AOC D was not under the collapsed roof area of the original warehouse and was accessible to the SI Team. A field sample was collected from the drum by the SI Team and field tested with a pH strip. The strip showed the pH of the liquid in the container to be less than one. The drum was a plastic-lined metal container. The metal at the base of the container was severely corroded so that it no longer provided any structural support to the container. The plastic liner in the drum was still intact and the drum was mostly full. The containers in AOC D are located approximately 20 feet from a catch basin inside of the warehouse structure. A release from these containers could potentially enter the catch basin and enter either the storm or sanitary sewer.

Description: View facing northwest of the drums in AOC D. The corroded drum on the left, approximately 35-gallons, was pH tested and found to contain a pH of less than 1.

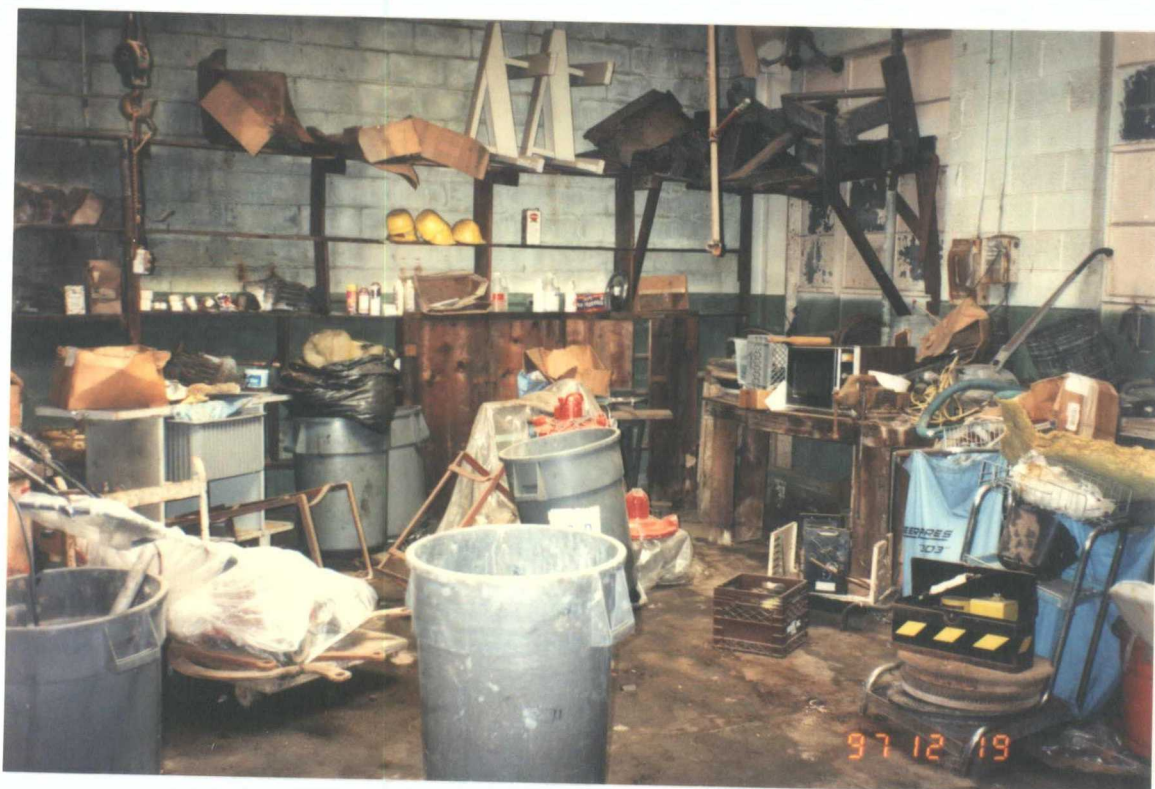
Photo No.: 1-19  
Date: 12/19/97

Description: Storage room in the northeast portion of the east addition. Some fluorescent light bulb ballasts were found, in labeled boxes, on shelves in this room.
